**Flood Control Project Maintenance
Levee Inspections**

Maintenance Issue Types Only, Levee Inspection Report By Mile - Spring 2020

Sutter Maintenance Yard Nelson Bend

Waterway	Bank	Unit Miles	Inspection Start/End	Inspector
Unit No. 01 Feather River West Levee - Nelson Bend		0.50	03/24/2020 03/24/2020	Sterling York

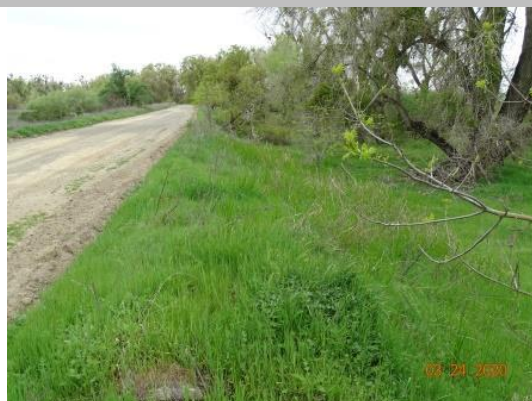
Photo 1 of 1 : SP_2020_ST0006_471_2_20200401_00011.jpg

LM Start	0.01	Rating **	U	Issue No.	2
LM End	0.50	Issue Type +	Ma	Location *	LS
Category	Earthen Levee			GPS Latitude/Longitude	
				Start	End
Item	Vegetation			38.887015 °	38.880306 °
				-121.614693 °	-121.614151 °
DWR ID	DWR_ST0006_01_f_2019_2				
Comment Code					
V1 : Control annual grass and weeds on the levee slopes and easements.					
Inspector Comment					
This levee is privately owned and not maintained by the LMA. The vegetation has not been maintained, Spring 2020.

View looking downstream landside at the annual vegetation that is not maintained, Spring 2020.

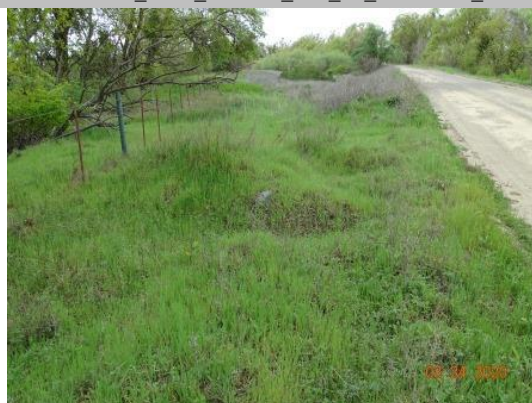
Photo 1 of 1 : SP_2020_ST0006_471_15_20200401_00010.jpg

LM Start	0.01	Rating **	U	Issue No.	15
LM End	0.50	Issue Type +	Ma	Location *	WS
Category	Earthen Levee			GPS Latitude/Longitude	
				Start	End
Item	Vegetation			38.887015 °	38.880306 °
				-121.614693 °	-121.614151 °
DWR ID	DWR_ST0006_01_f_2019_15				
Comment Code					
V1 : Control annual grass and weeds on the levee slopes and easements.					
Inspector Comment					
This levee is privately owned and not maintained by the LMA. The vegetation has not been maintained, Spring 2020.

View looking downstream waterside at the annual vegetation that is not maintained, Spring 2020.

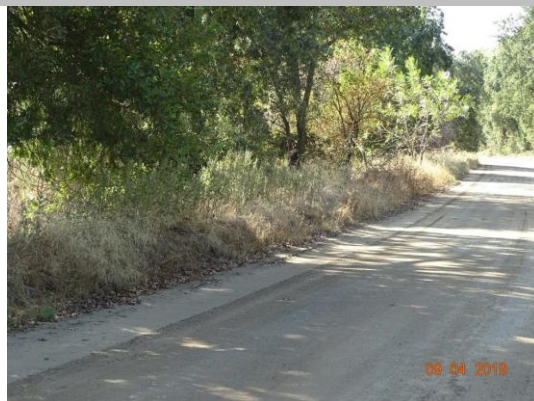
Photo 1 of 1 : SP_2020_ST0006_471_1_20200227_00001.jpg

LM Start	0.13	Rating **	U	Issue No.	1
LM End	0.50	Issue Type +	Ma	Location *	WS
Category	Earthen Levee			GPS Latitude/Longitude	
				Start	End
Item	Trim / Thin Trees			38.885396 °	38.880295 °
				-121.615595 °	-121.614147 °
DWR ID	DWR_ST0006_01_f_2017_1				
Comment Code					
T3 : Trim and thin trees to allow visibility of the ground and room to flood fight.					
Inspector Comment					
Trim up the trees to 5 feet above the ground for access and visibility, Spring 2020.

View looking downstream waterside of the over growth of trees.

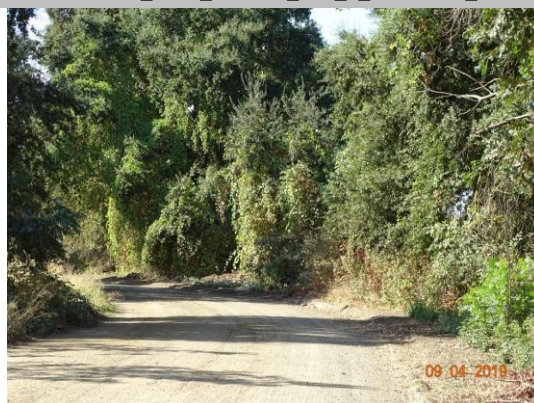
Photo 1 of 1 : SP_2020_ST0006_471_3_20200227_00003.jpg

LM Start	0.13	Rating **	U	Issue No.	3
LM End	0.50	Issue Type +	Ma	Location *	LS
Category	Earthen Levee			GPS Latitude/Longitude	
				Start	End
Item	Trim / Thin Trees			38.885396 °	38.880295 °
				-121.615595 °	-121.614147 °
DWR ID	DWR_ST0006_01_f_2017_3				
Comment Code					
T3 : Trim and thin trees to allow visibility of the ground and room to flood fight.					
Inspector Comment					
Trim up the trees to 5 feet above the ground for access and visibility, Spring 2020.

View looking downstream landside of the over growth of trees.
